# Manhole Inspection Summary

Manhole # S37WW\_009MH

Insp Date: 1/10/07 12:20 PM

**Location** Address: **808 MONTPELIER ST**

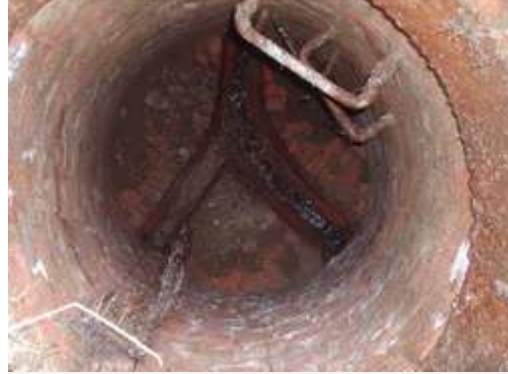
Top View

☒ **Debris** (not Condition related)

☒ **Corroded**

☒ **Evidence Of Surcharge**

Corroded steps. Evidence of surcharge - Bench debris.

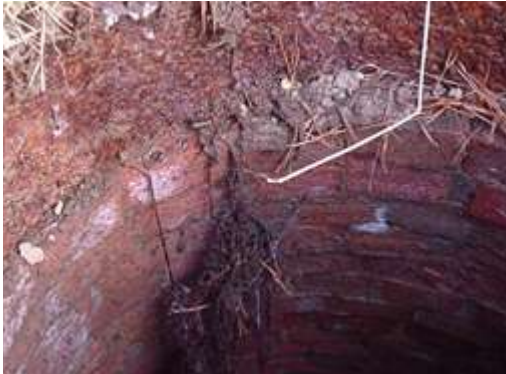
Defect

Offset: **2** (in.)

☒ **Root Intrusion**

☒ **Deteriorated**

Frame offset. Adjustment deterioration, root intrusion and infiltration.

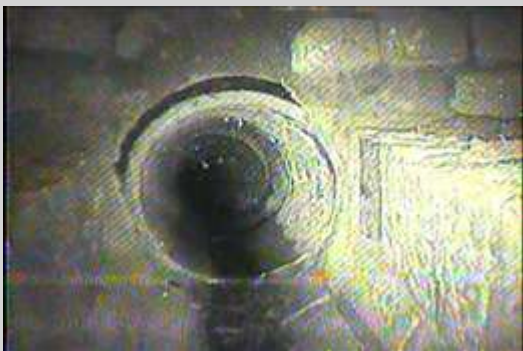
### 8 in. Circular Gravity Sewer Pipe In @ 4 O'Clock

Infiltration: **None** Pipe Seal Cond: **Cracked**
